**Flood Control Project Maintenance
Levee Inspections**

2018 Channel Summary Report

Merced Streams Group

Levee Inspection Report By Mile - Channel 2018

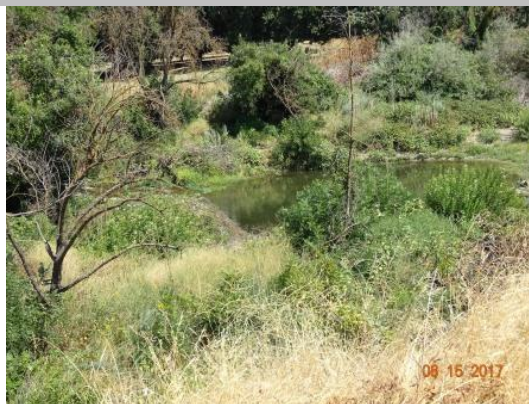
Photo 2 of 2 : CH_2018_NA0013_34_26_20180608_00004.jpg

Rating **	U	Issue No.	26 (cont)	GPS Lat/Long
Issue Type +	Ma	Location *		37.333581 °
Category	Rivers, Channels & Designated Flood			-120.320642 °
Item	Vegetation & Obstructions			
DWR ID	DWR_NA0013_34_c_2016_26			
Action/Comments				
Inspector Comments: This vantage point is on private property looking across the channel. The channel is not maintained, and overgrown brush along banks needs to be controlled or removed.

The Confluence of the Burns and Bear Creeks viewed from private property on right bank. Summer 2017

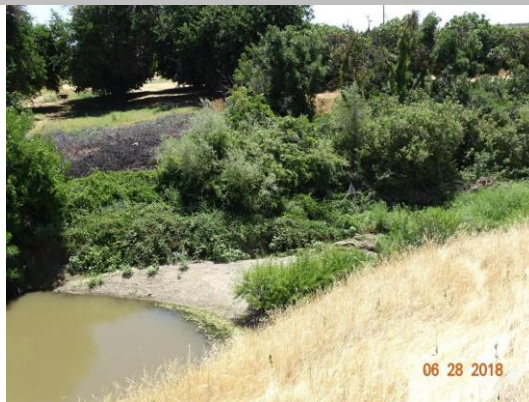
Photo 1 of 1 : CH_2018_NA0013_34_27_20180710_00015.jpg

Rating **	U	Issue No.	27	GPS Lat/Long
Issue Type +	Ma	Location *		37.333581 °
Category	Rivers, Channels & Designated Flood			-120.320642 °
Item	Shoaling / Sedimentation			
DWR ID	DWR_NA0013_34_c_2016_27			
Action/Comments				
Inspector Comments: The shoaling with established vegetation may impede flow and needs to be removed.

View of shoaling with established vegetation downstream of the confluence. Summer 2018

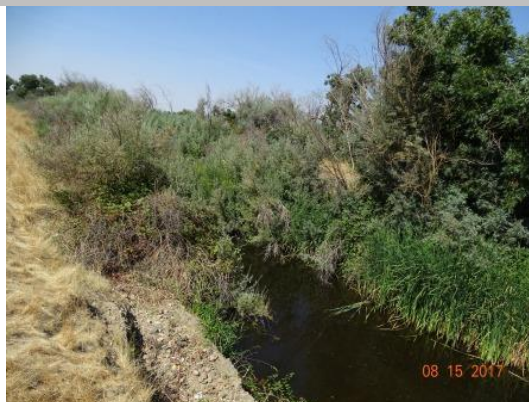
Photo 1 of 1 : CH_2018_NA0013_34_31_20180608_00005.jpg

Rating **	U	Issue No.	31	GPS Lat/Long
Issue Type +	Ma	Location *		37.336437 °
Category	Rivers, Channels & Designated Flood			-120.317618 °
Item	Vegetation & Obstructions			
DWR ID	DWR_NA0013_34_c_2016_31			
Action/Comments				
Inspector Comments: This location is overgrown with wild growth. Access is limited to this channel.

Burns Creek looking upstream from the low water crossing.

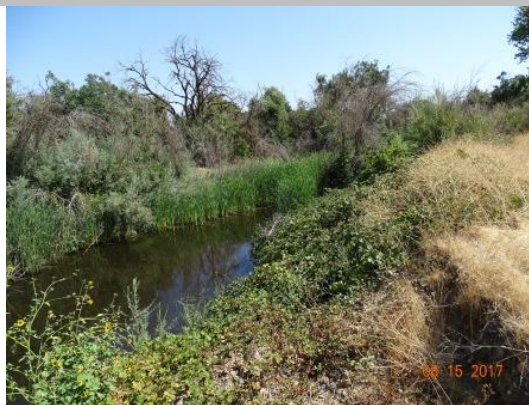
Photo 1 of 1 : CH_2018_NA0013_34_37_20180608_00006.jpg

Rating **	U	Issue No.	37	GPS Lat/Long
Issue Type +	Ma	Location *		37.336437 °
Category	Rivers, Channels & Designated Flood			-120.317618 °
Item	Vegetation & Obstructions			
DWR ID	DWR_NA0013_34_c_2016_37			
Action/Comments				
Inspector Comments: The channel here is completely over grown and has never been maintained. Access to this creek is very limited due to private property.

View of Burns Creek from the low water crossing.

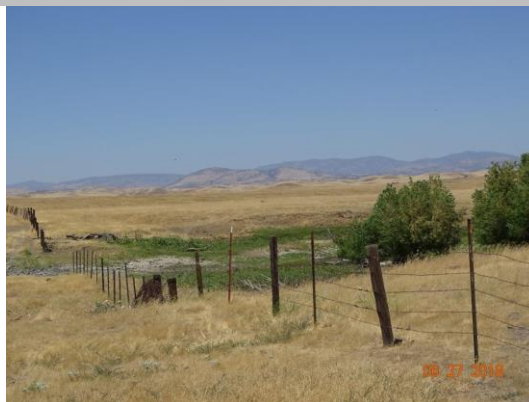
Photo 1 of 2 : CH_2018_NA0013_35_1_20180711_00048.jpg

View of vegetation in channel. Summer 2018

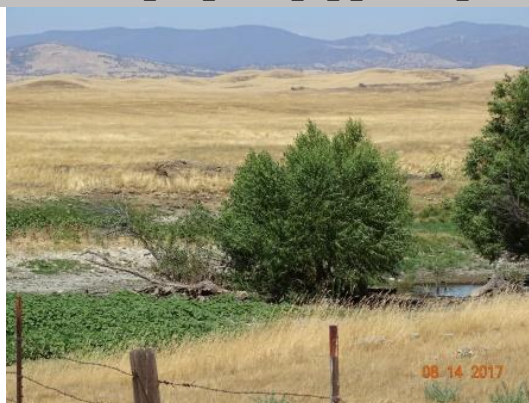
Photo 2 of 2 : CH_2018_NA0013_35_1_20180608_00001.jpg

Looking upstream of Mariposa Creek from White Rock Road. Summer 2017

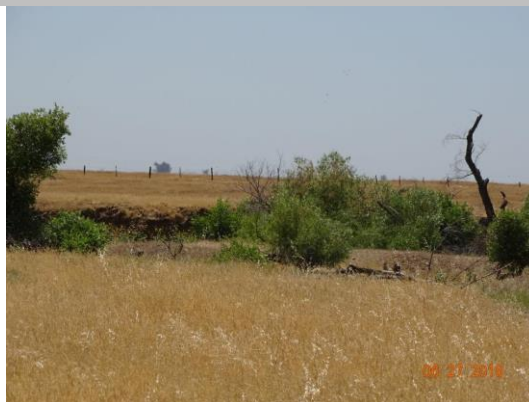
Photo 1 of 2 : CH_2018_NA0013_35_6_20180711_00049.jpg

View of vegetation in channel. Summer 2018

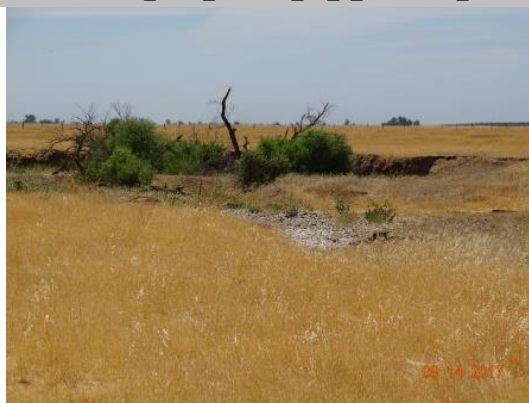
Photo 2 of 2 : CH_2018_NA0013_35_6_20180608_00002.jpg

Looking downstream from White Road at Mariposa Creek. Summer 2017

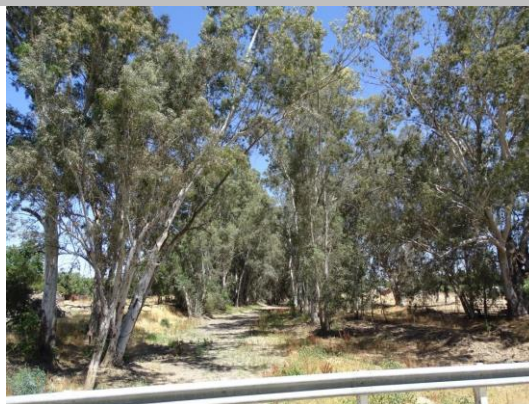
Photo 1 of 2 : CH_2018_NA0013_35_11_20180711_00050.jpg

View of vegetation in channel. Summer 2018

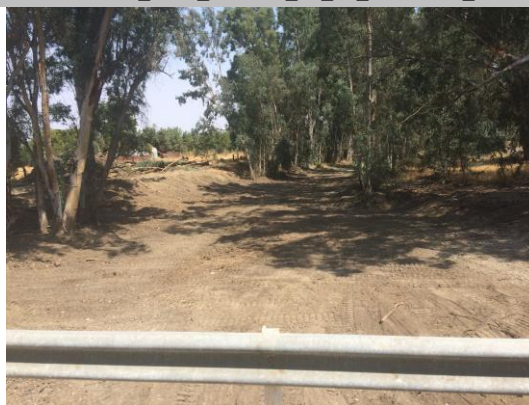
Photo 2 of 2 : CH_2018_NA0013_35_11_20180608_00003.jpg

Looking upstream from the Fresno Road crossing the Mariposa Creek.
Summer 2017

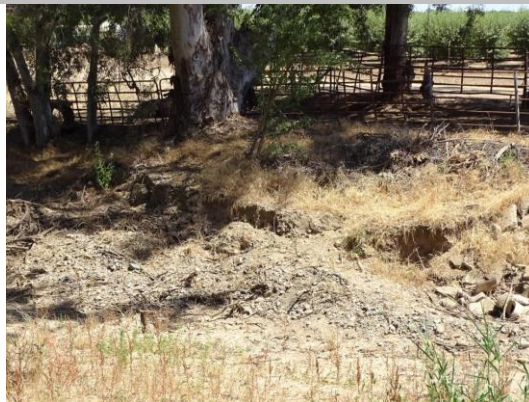
Photo 1 of 1 : CH_2018_NA0013_35_13_20180711_00051.jpg

Inspector Comments: Erosion along the left bank may affect the crossing in the future.

View of erosion along left bank. Summer 2018

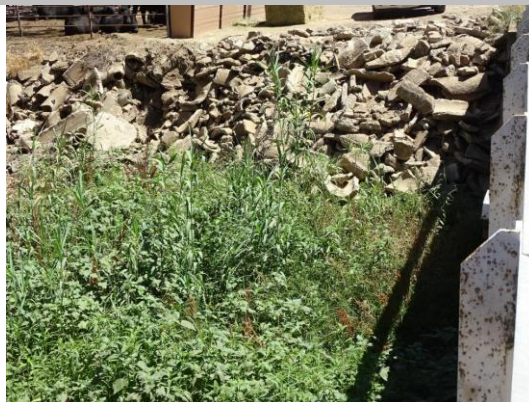
Photo 1 of 2 : CH_2018_NA0013_35_14_20180711_00052.jpg

Inspector Comments: Riprap is clearly visible.

View of the revetment on the left bank. Summer 2018

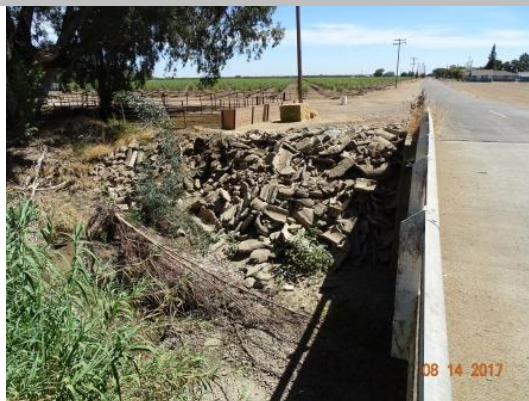
Photo 2 of 2 : CH_2018_NA0013_35_14_20180608_00004.jpg

View of the revetment on the channel bank. Summer 2017

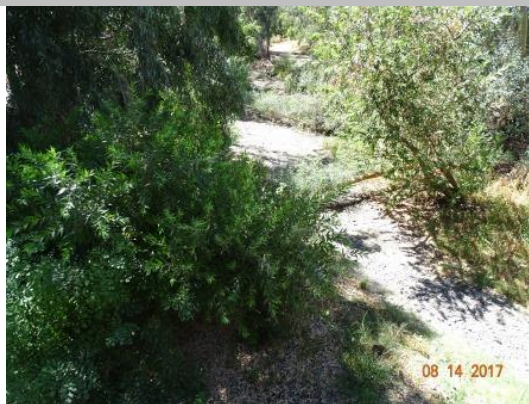
Photo 3 of 3 : CH_2018_NA0013_35_16_20180608_00005.jpg

Check Point / View				
Fresno Rd / Down (cont)				
Rating **	U	Issue No.	16 (cont)	GPS Lat/Long
Issue Type +	Ma	Location *		37.237998 °
Category	Rivers, Channels & Designated Flood			-120.243649 °
Item	Vegetation & Obstructions			
DWR ID	DWR_NA0013_35_c_2016_16			
Action/Comments				
Inspector Comments: Excessive wild growth and woody vegetation may impede the channel capacity.

Mariposa Creek looking downstream from the Fresno Road Crossing.
Summer 2017

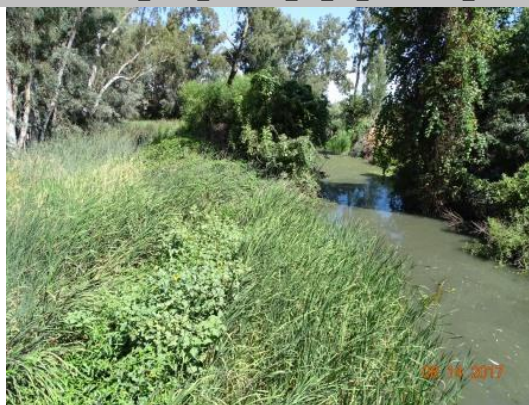
Photo 2 of 3 : CH_2018_NA0013_35_21_20180608_00006.jpg

Looking upstream from the Cunningham Rd Crossing. Summer 2017

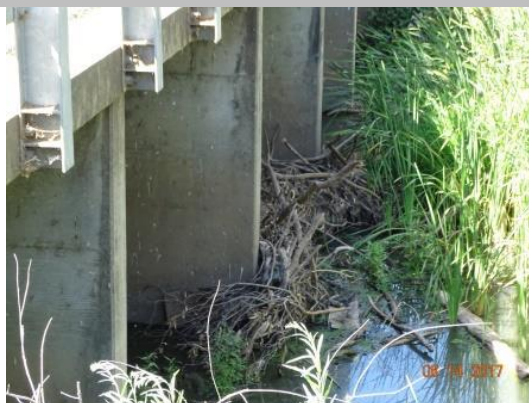
Photo 3 of 3 : CH_2018_NA0013_35_21_20180608_00007.jpg

View of the debris at the bridge. Summer 2017

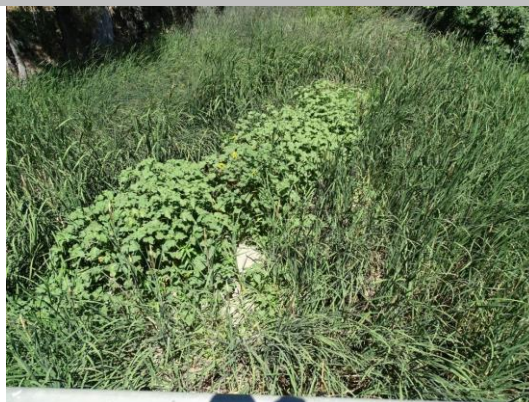
Photo 1 of 2 : CH_2018_NA0013_35_22_20180711_00057.jpg

Inspector Comments: Shoaling with vegetation may impede flow in the future and should be controlled.

Shoaling with vegetation in the channel. Summer 2018

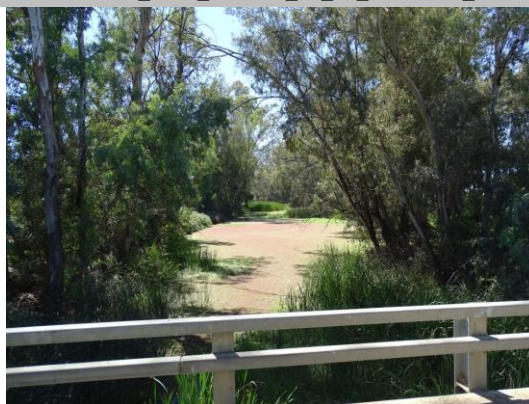
Photo 1 of 3 : CH_2018_NA0013_35_26_20180711_00058.jpg

Rating **	A	Issue No.	26	GPS Lat/Long
Issue Type +	Ma	Location *		37.238920 °
Category	Rivers, Channels & Designated Flood			-120.252701 °
Item	Vegetation & Obstructions			
DWR ID	DWR_NA0013_35_c_2016_26			
Action/Comments				
Inspector Comments: There is some vegetation in the channel, but it does not appear to impede flow at this time.

View of vegetation in the channel. Summer 2018

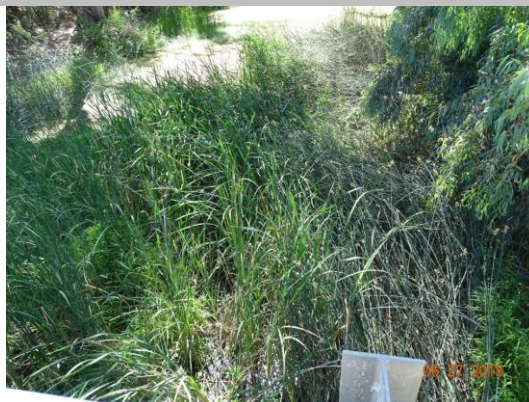
Photo 2 of 3 : CH_2018_NA0013_35_26_20180711_00059.jpg

Inspector Comments: There is some vegetation in the channel, but it does not appear to impede flow at this time.

View of vegetation along the right bank. Summer 2018

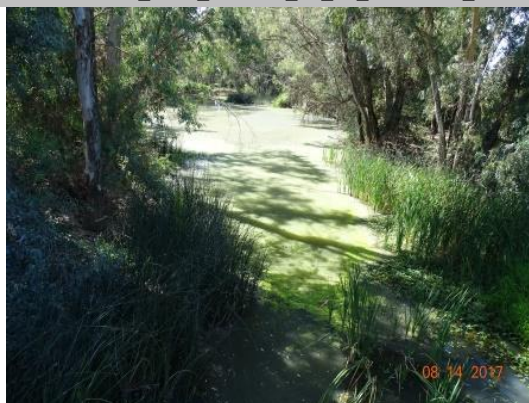
Photo 3 of 3 : CH_2018_NA0013_35_26_20180608_00009.jpg

Looking downstream from the Cunningham Bridge crossing the Mariposa Creek. Summer 2017

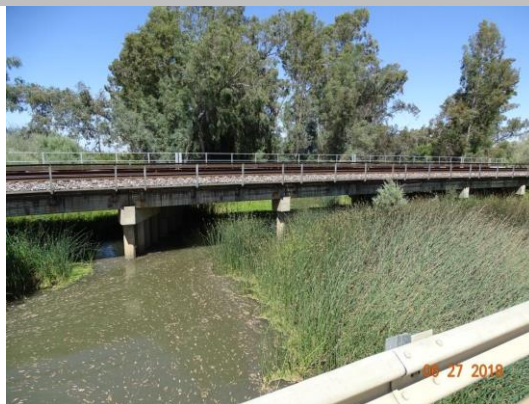
Photo 1 of 2 : CH_2018_NA0013_35_31_20180711_00060.jpg

Inspector Comments: Vegetation in the channel is growing but does not appear to impede flow.

View of vegetation in the channel. Summer 2018

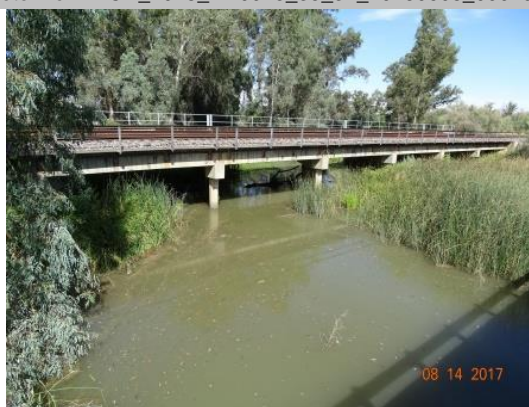
Photo 2 of 2 : CH_2018_NA0013_35_31_20180608_00010.jpg

Looking upstream of the RR Bridge near Santa Fe Dr. Summer 2017

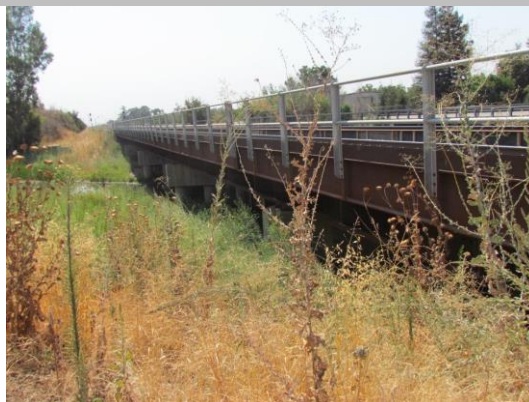
Photo 3 of 3 : CH_2018_NA0013_35_35_20180608_00013.jpg

Inspector Comments: The dead trees noted in 2017 appear to have been removed or dislodged from the crossing. The new RR bridge crossing was not authorized by CVFPB, and BNSF needs to secure a permit.

Looking at the New RR Bridge line from upstream right bank.

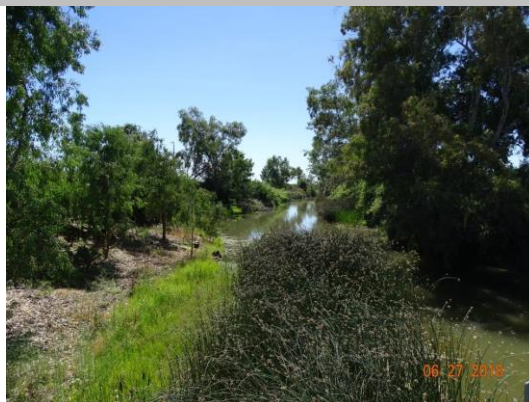
Photo 1 of 2 : CH_2018_NA0013_35_36_20180711_00061.jpg

Inspector Comments: The vegetation in the channel should be managed before it impedes that capacity.

View of vegetation in the channel. Summer 2018

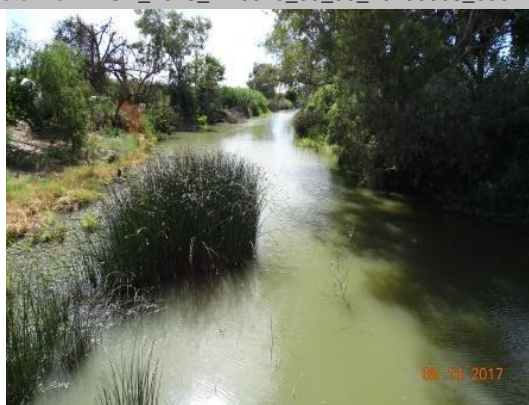
Photo 2 of 2 : CH_2018_NA0013_35_36_20180608_00014.jpg

Looking downstream from Santa Fe Dr. Mariposa Creek. Summer 2017

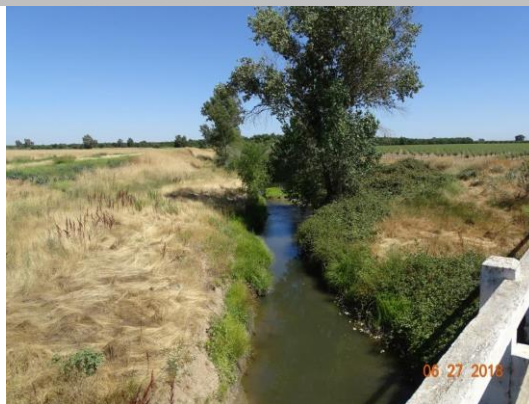
Photo 1 of 1 : CH_2018_NA0013_35_41_20180711_00062.jpg

View of vegetation in the channel. Summer 2018

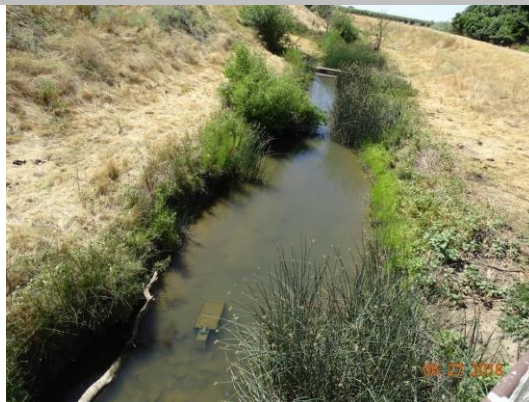
Photo 1 of 2 : CH_2018_NA0013_35_46_20180711_00063.jpg

Rating **	A	Issue No.	46	GPS Lat/Long
Issue Type +	Ma	Location *		37.257235 °
Category	Rivers, Channels & Designated Flood			-120.288731 °
Item	Vegetation & Obstructions			
DWR ID	DWR_NA0013_35_c_2016_46			
Action/Comments				
Inspector Comments: Vegetation along the banks improved.

View of vegetation in the channel and along banks. Summer 2018

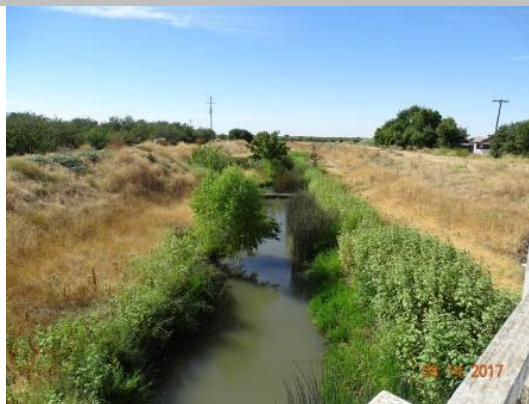
Photo 2 of 2 : CH_2018_NA0013_35_46_20180608_00016.jpg

Rating **	A	Issue No.	46 (cont)	GPS Lat/Long
Issue Type +	Ma	Location *		37.257235 °
Category	Rivers, Channels & Designated Flood			-120.288731 °
Item	Vegetation & Obstructions			
DWR ID	DWR_NA0013_35_c_2016_46			
Action/Comments				
Inspector Comments: Vegetation along the banks improved.

Looking downstream from the Burchell Rd crossing. Summer 2017

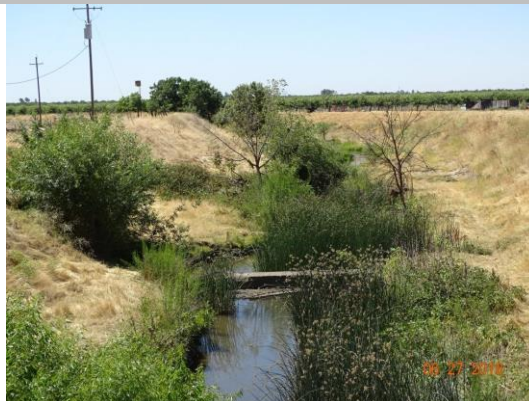
Photo 2 of 5 : CH_2018_NA0013_35_50_20180711_00064.jpg

View of concrete dam across channel. Summer 2018

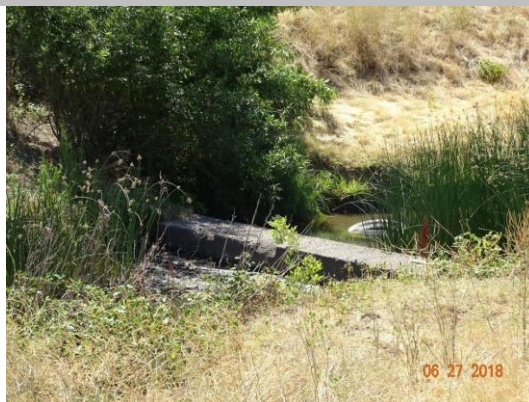
Photo 3 of 5 : CH_2018_NA0013_35_50_20180711_00065.jpg

View of concrete dam across channel. Summer 2018

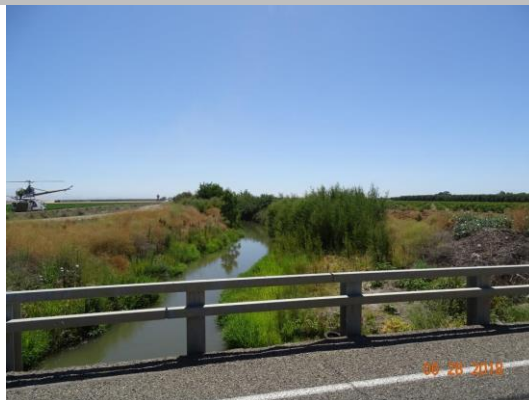
Photo 1 of 3 : CH_2018_NA0013_35_51_20180711_00068.jpg

Inspector Comments: The vegetation along the banks and the log debris underneath the crossing need to be addressed.

View of vegetation along channel banks. Summer 2018

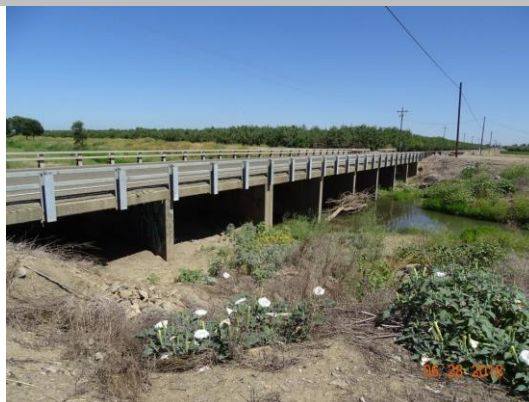
Photo 2 of 3 : CH_2018_NA0013_35_51_20180711_00067.jpg

View of logs caught up underneath crossing. Summer 2018

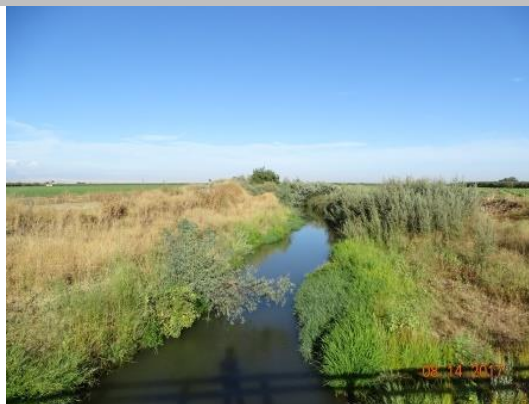
Photo 3 of 3 : CH_2018_NA0013_35_51_20180608_00019.jpg

Inspector Comments: The vegetation along the banks and the log debris underneath the crossing need to be addressed.

Looking upstream from Plainsbug Rd. Summer 2017

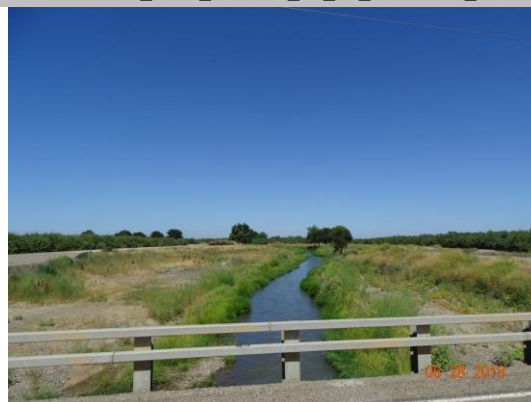
Photo 1 of 2 : CH_2018_NA0013_35_56_20180711_00069.jpg

Rating **	A	Issue No.	56	GPS Lat/Long
Issue Type +	Ma	Location *		37.258430 °
Category	Rivers, Channels & Designated Flood			-120.325070 °
Item	Vegetation & Obstructions			
DWR ID	DWR_NA0013_35_c_2016_56			
Action/Comments				
Inspector Comments: Channel has vegetation growth on both banks, but flow does not appear to be impeded.

View of vegetation along banks. Summer 2018

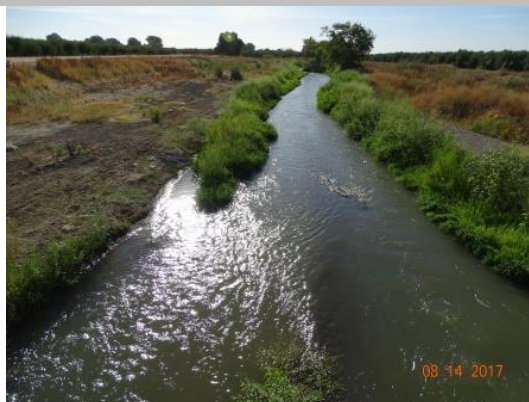
Photo 2 of 2 : CH_2018_NA0013_35_56_20180608_00021.jpg

Inspector Comments: Channel has vegetation growth on both banks, but flow does not appear to be impeded.

Mariposa Creek looking downstream from Plainsburg Road Crossing.
Summer 2017

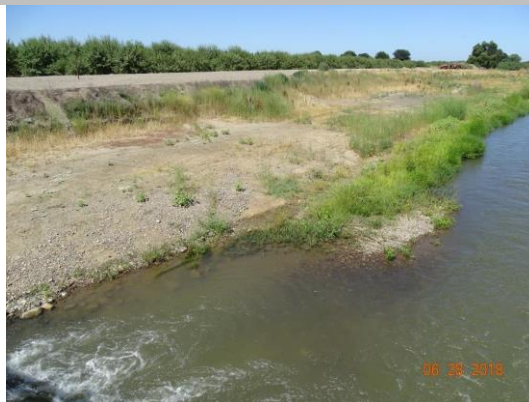
Photo 1 of 2 : CH_2018_NA0013_35_57_20180711_00070.jpg

Inspector Comments: There is sedimentation in the channel, but flow does not appear to be impeded.

View of sedimentation along the left bank. Summer 2018

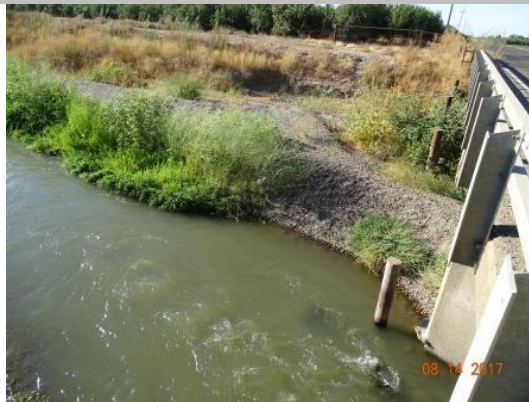
Photo 2 of 2 : CH_2018_NA0013_35_57_20180608_00022.jpg

View of the sediment buildup in the channel. Summer 2017

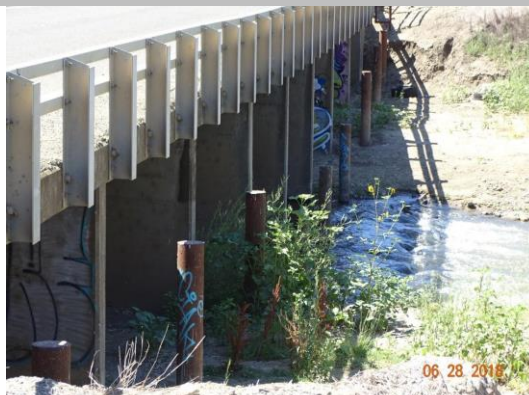
Photo 1 of 2 : CH_2018_NA0013_35_60_20180711_00072.jpg

View of metal posts installed across the channel. Summer 2018

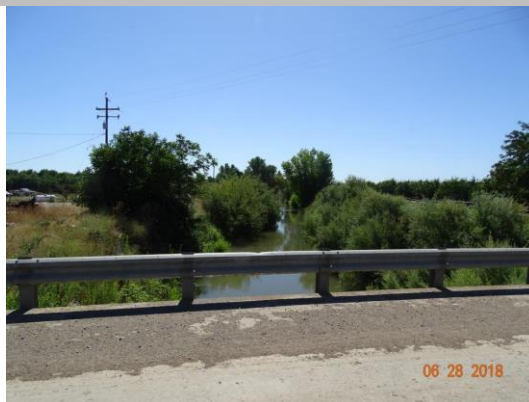
Photo 1 of 3 : CH_2018_NA0013_35_61_20180711_00073.jpg

View of vegetation along banks. Summer 2018

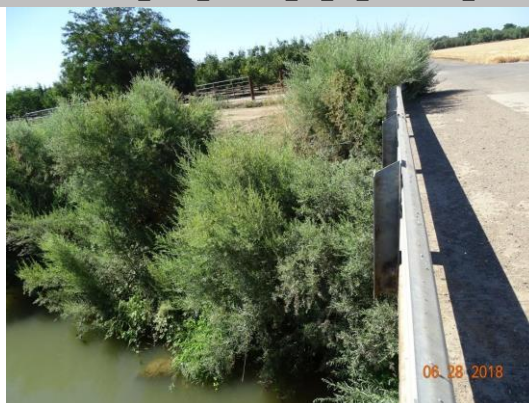
Photo 2 of 3 : CH_2018_NA0013_35_61_20180711_00074.jpg

View of vegetation underneath crossing. Summer 2018

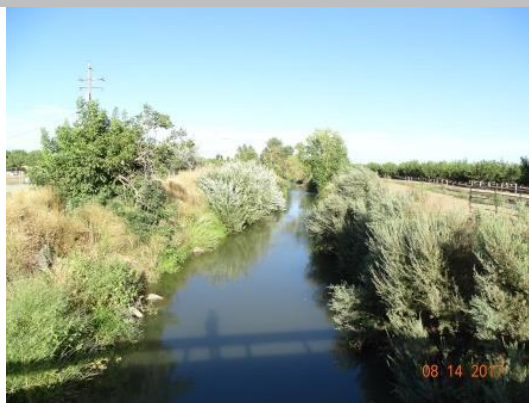
Photo 3 of 3 : CH_2018_NA0013_35_61_20180608_00026.jpg

Looking upstream from Whealan Rd. crossing the Mariposa Creek.
Summer 2017

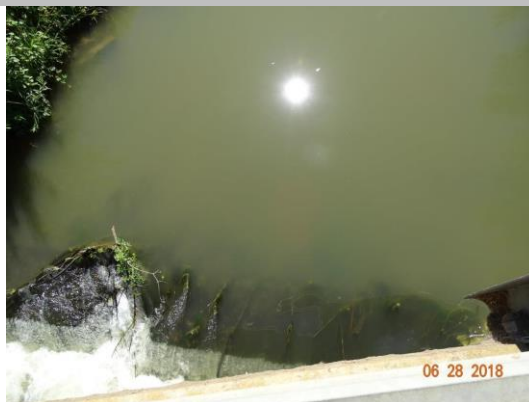
Photo 1 of 1 : CH_2018_NA0013_35_65_20180711_00075.jpg

Inspector Comments: This concrete weir structure does not appear to have a permit.

View of a concrete weir underneath the crossing. Summer 2018

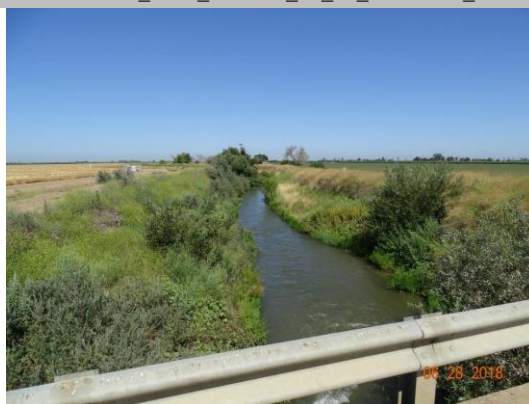
Photo 1 of 3 : CH_2018_NA0013_35_66_20180711_00076.jpg

View of vegetation along banks. Summer 2018

Inspector Comments: The vegetation growth on both banks needs to be controlled.

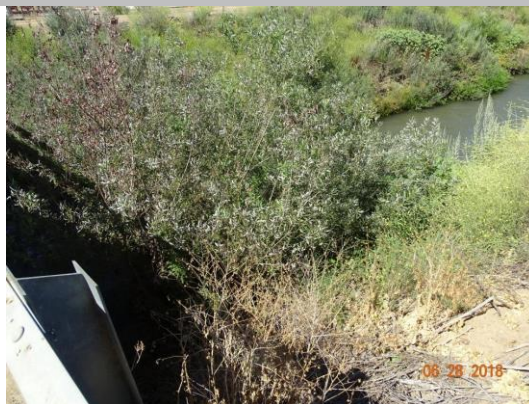
Photo 2 of 3 : CH_2018_NA0013_35_66_20180711_00077.jpg

View of vegetation adjacent to crossing. Summer 2018

Inspector Comments: The vegetation growth on both banks needs to be controlled.

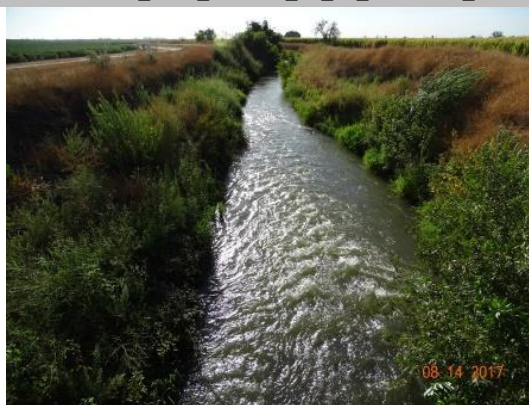
Photo 3 of 3 : CH_2018_NA0013_35_66_20180608_00027.jpg

Looking downstream from the Whealan Rd. crossing. Summer 2017

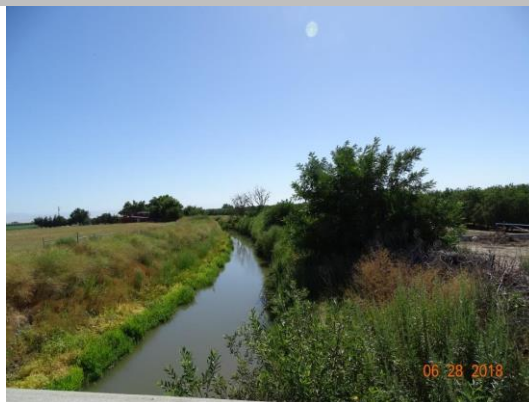
Photo 1 of 3 : CH_2018_NA0013_35_71_20180711_00078.jpg

View of vegetation along banks. Summer 2018

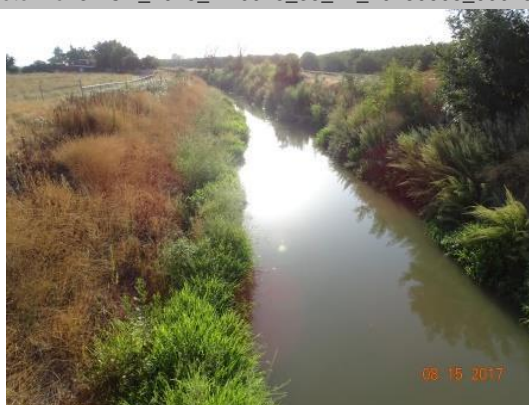
Photo 2 of 3 : CH_2018_NA0013_35_71_20180608_00028.jpg

Looking upstream from the Arboleda Rd Bridge crossing. Summer 2017

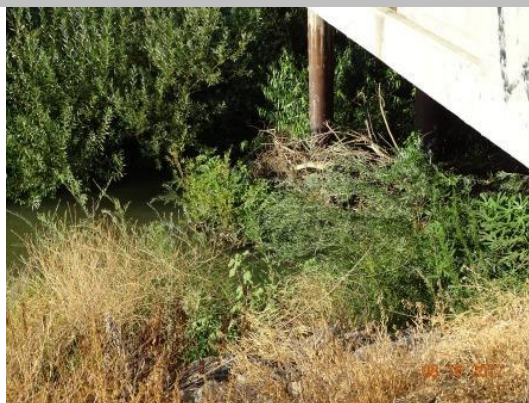
Photo 3 of 3 : CH_2018_NA0013_35_71_20180608_00029.jpg

View of the debris collection under the bridge. Summer 2017

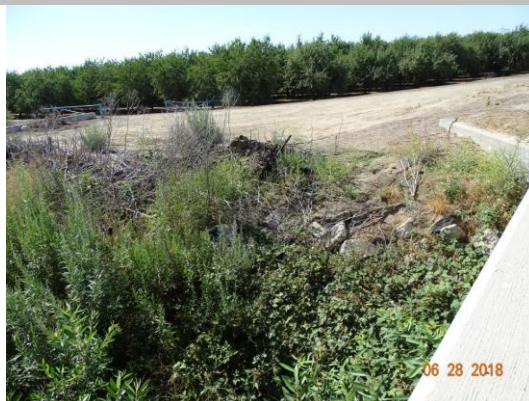
Photo 1 of 4 : CH_2018_NA0013_35_74_20180711_00079.jpg

Rating **	A	Issue No.	74	GPS Lat/Long
Issue Type +	Ma	Location *		37.257036 °
Category	Rivers, Channels & Designated Flood			-120.379219 °
Item	Revetments			
DWR ID	DWR_NA0013_35_c_2016_74			
Action/Comments				
Inspector Comments: Revetment consists of broken concrete and is visible on both banks.

View of left bank riprap. Summer 2018

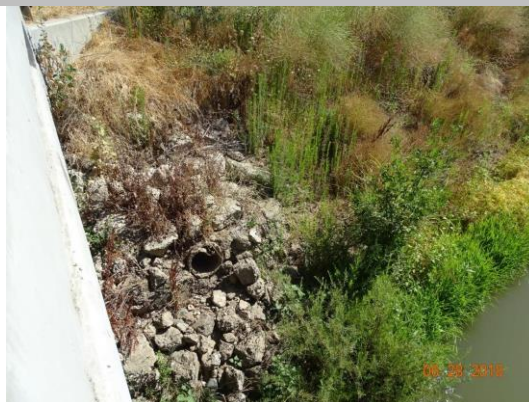
Photo 2 of 4 : CH_2018_NA0013_35_74_20180711_00080.jpg

Inspector Comments: Revetment consists of broken concrete and is visible on both banks.

View of right bank riprap. Summer 2018

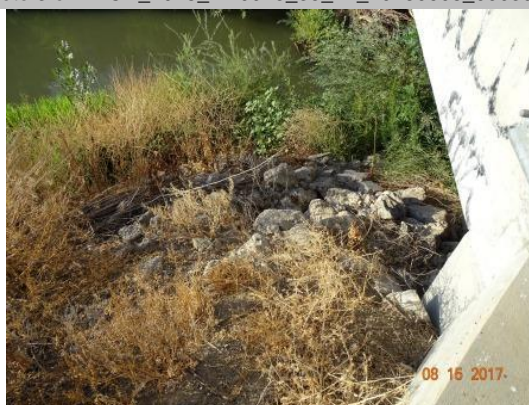
Photo 3 of 4 : CH_2018_NA0013_35_74_20180608_00030.jpg

Looking at the revetment at right bank upstream of the Mariposa Creek. Summer 2017

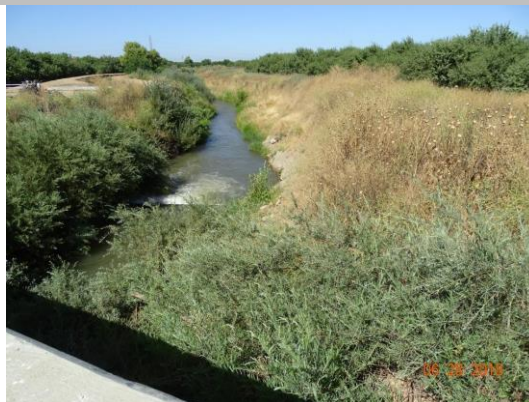
Photo 1 of 2 : CH_2018_NA0013_35_76_20180712_00081.jpg

Rating **	A	Issue No.	76	GPS Lat/Long
Issue Type +	Ma	Location *		37.257036 °
Category	Rivers, Channels & Designated Flood			-120.379219 °
Item	Vegetation & Obstructions			
DWR ID	DWR_NA0013_35_c_2016_76			
Action/Comments				
Inspector Comments: Some vegetation was present, but flow is not impeded at this time.

View of vegetation in the channel and along the banks. Summer 2018

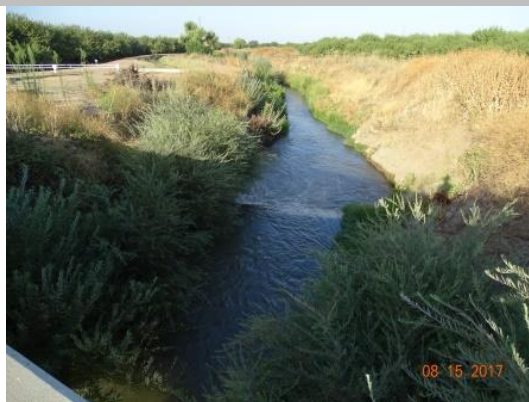
Photo 2 of 2 : CH_2018_NA0013_35_76_20180608_00032.jpg

Rating **	A	Issue No.	76 (cont)	GPS Lat/Long
Issue Type +	Ma	Location *		37.257036 °
Category	Rivers, Channels & Designated Flood			-120.379219 °
Item	Vegetation & Obstructions			
DWR ID	DWR_NA0013_35_c_2016_76			
Action/Comments				
Inspector Comments: Some vegetation was present, but flow is not impeded at this time.

Looking at the downstream side of Arboleda Rd. crossing. Summer 2017

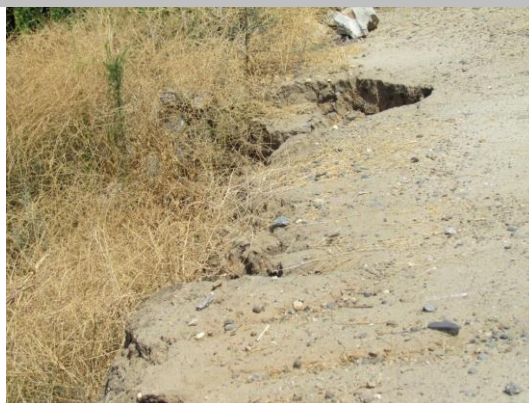
Photo 4 of 5 : CH_2018_NA0013_35_78_20180608_00035.jpg

Standing on the left bank looking back upstream of the erosion present on the top of bank.

Rating **	U	Issue No.	78 (cont)	GPS Lat/Long
Issue Type +	Ma	Location *		37.256910 °
Category	Rivers, Channels & Designated Flood			-120.379490 °
Item	Erosion / Bank Caving			
DWR ID	DWR_NA0013_35_c_2016_78

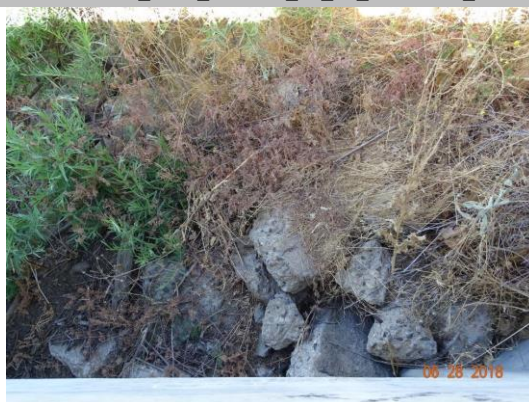
Photo 1 of 1 : CH_2018_NA0013_35_79_20180712_00099.jpg

Inspector Comments: There is riprap on the right bank that is mostly visible.

View of riprap on right bank. Summer 2018

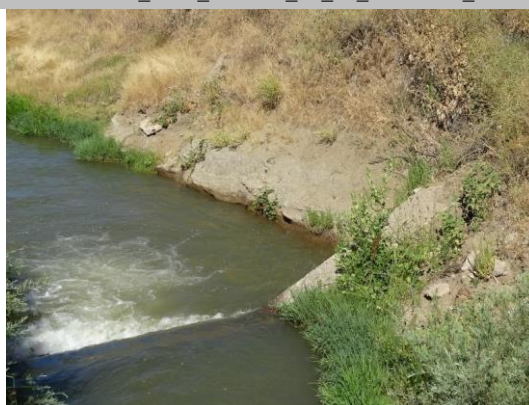
Photo 1 of 1 : CH_2018_NA0013_35_80_20180712_00083.jpg

Inspector Comments: A longstanding concrete weir structure exists across the channel without an apparent permit.

View of a longstanding concrete weir structure across channel. Summer 2018

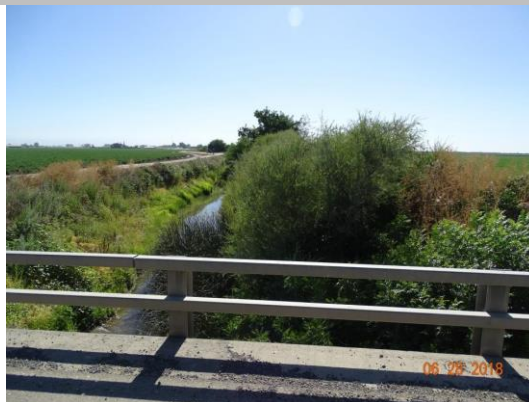
Photo 1 of 3 : CH_2018_NA0013_35_81_20180712_00084.jpg

View of vegetation along banks. Summer 2018

Inspector Comments: Control the wild growth on both banks, and remove debris from underneath the crossing.

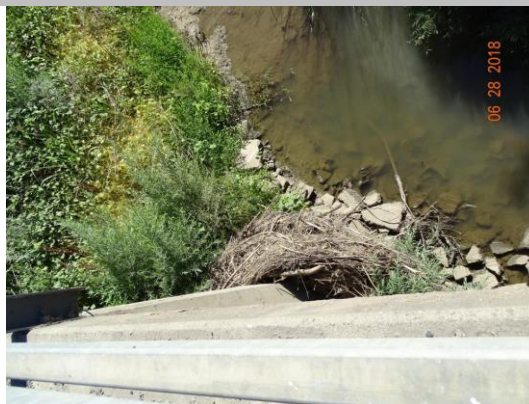
Photo 2 of 3 : CH_2018_NA0013_35_81_20180712_00085.jpg

View of vegetation debris underneath the crossing. Summer 2018

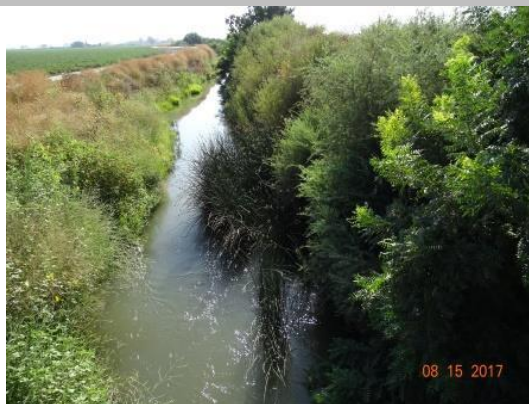
Photo 3 of 3 : CH_2018_NA0013_35_81_20180608_00037.jpg

Looking upstream from the Healy Rd. crossing. Summer 2017

Check Point / View				
Healy Rd / Up (cont)				
Rating **	M	Issue No.	81 (cont)	GPS Lat/Long
Issue Type +	Ma	Location *		37.246003 °
Category	Rivers, Channels & Designated Flood			-120.434235 °
Item	Vegetation & Obstructions			
DWR ID	DWR_NA0013_35_c_2016_81			
Action/Comments				
Inspector Comments: Control the wild growth on both banks, and remove debris from underneath the crossing.

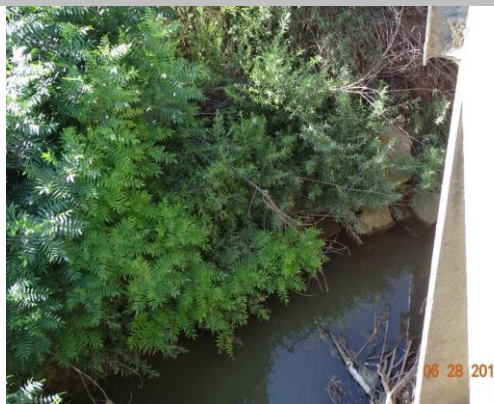
Photo 1 of 1 : CH_2018_NA0013_35_84_20180712_00086.jpg

View of revetment covered by vegetation on left bank. Summer 2018

Check Point / View				
Healy Rd / Up (cont)				
Rating **	M	Issue No.	84	GPS Lat/Long
Issue Type +	Ma	Location *		37.246003 °
Category	Rivers, Channels & Designated Flood			-120.434235 °
Item	Revetments			
DWR ID	DWR_NA0013_35_c_2016_84			
Action/Comments				
Inspector Comments: Unwanted vegetation over riprap must be cleared.

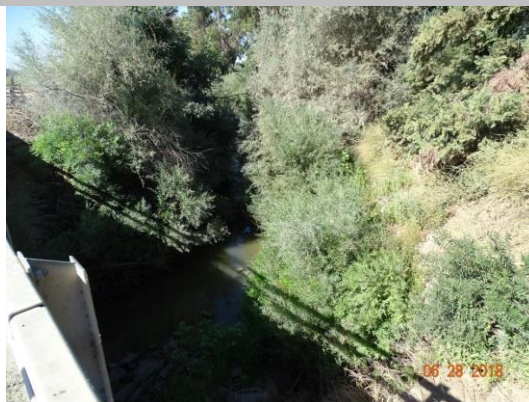
Photo 1 of 2 : CH_2018_NA0013_35_86_20180712_00087.jpg

View of vegetation in the channel and along banks. Summer 2018

Rating **	U	Issue No.	86	GPS Lat/Long
Issue Type +	Ma	Location *		37.246003 °
Category	Rivers, Channels & Designated Flood			-120.434235 °
Item	Vegetation & Obstructions			
DWR ID	DWR_NA0013_35_c_2016_86			
Action/Comments				
Inspector Comments: Control the wild vegetation growth on both banks of the channel.

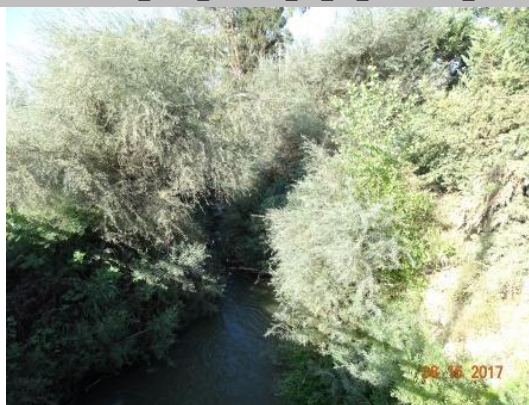
Action/Comments

Looking downstream from the Healy Rd. crossing. Summer 2017

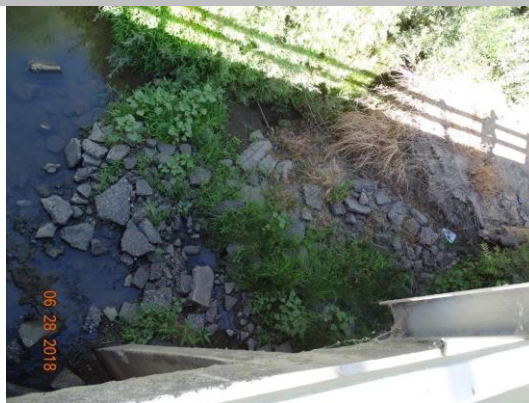
Photo 1 of 2 : CH_2018_NA0013_35_89_20180712_00090.jpg

Inspector Comments: Vegetation covering riprap needs to be cleared.

View of revetment partially covered by vegetation. Summer 2018

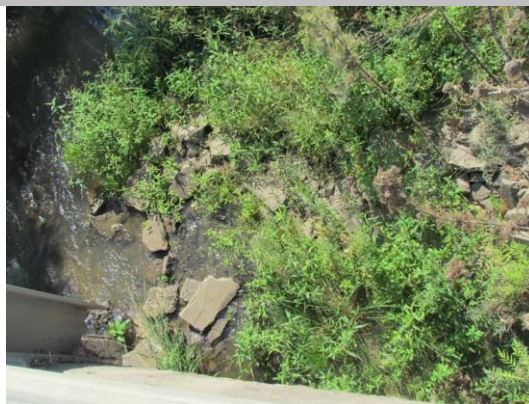
Photo 2 of 2 : CH_2018_NA0013_35_89_20180608_00039.jpg

Rating **	A	Issue No.	89 (cont)	GPS Lat/Long
Issue Type +	Ma	Location *		37.246003 °
Category	Rivers, Channels & Designated Flood			-120.434235 °
Item	Revetments			
DWR ID	DWR_NA0013_35_c_2016_89			
Action/Comments				
Inspector Comments: Vegetation covering riprap needs to be cleared.

Some of the revetment can be seen through the wild growth. Summer 2017

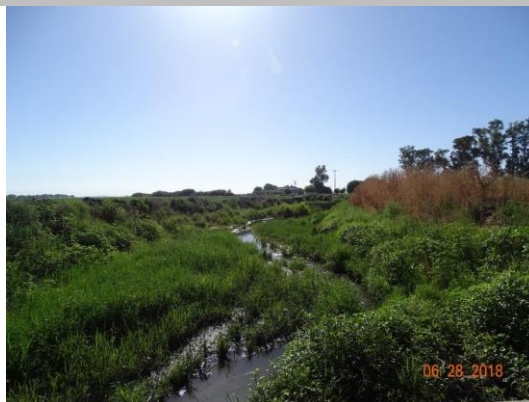
Photo 1 of 2 : CH_2018_NA0013_35_91_20180712_00091.jpg

Inspector Comments: There appears to be some improvement, but vegetation management in this area still needed.

View of vegetation in the channel and along banks. Summer 2018

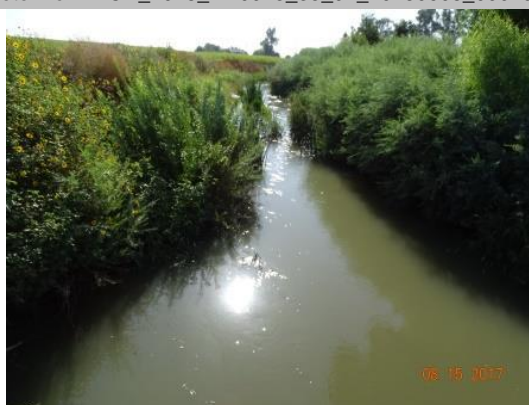
Photo 2 of 2 : CH_2018_NA0013_35_91_20180608_00040.jpg

Looking upstream of Mariposa Creek from HWY 59 crossing. Summer 2017

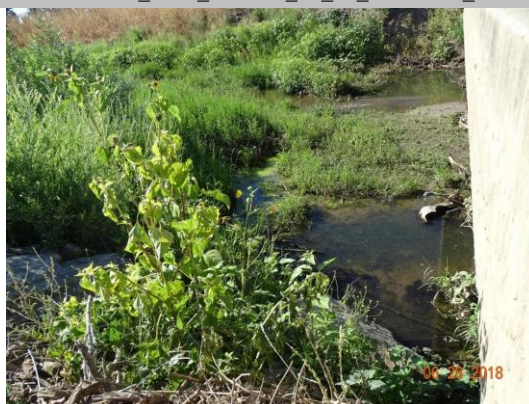
Photo 1 of 2 : CH_2018_NA0013_35_92_20180712_00092.jpg

Inspector Comments: Non-aquatic grasses are present on shoal but do not appear to impede flow at this time.

View of shoal with vegetation. Summer 2018

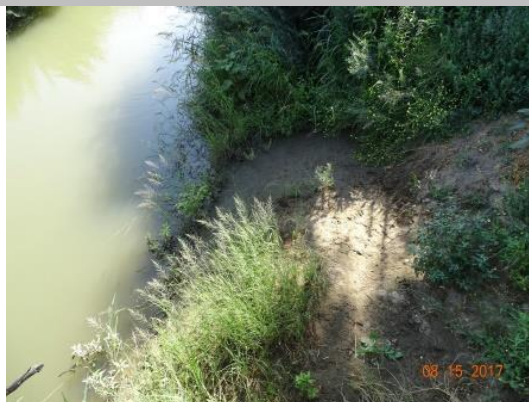
Photo 2 of 2 : CH_2018_NA0013_35_92_20180608_00041.jpg

Check Point / View				
Hwy 59 / Up (cont)				
Rating **	M	Issue No.	92 (cont)	GPS Lat/Long
Issue Type +	Ma	Location *		37.233949 °
Category	Rivers, Channels & Designated Flood			-120.488009 °
Item	Shoaling / Sedimentation			
DWR ID	DWR_NA0013_35_c_2016_92			
Action/Comments				
Inspector Comments: Non-aquatic grasses are present on shoal but do not appear to impede flow at this time.

View of the shoal in the channel. Summer 2017

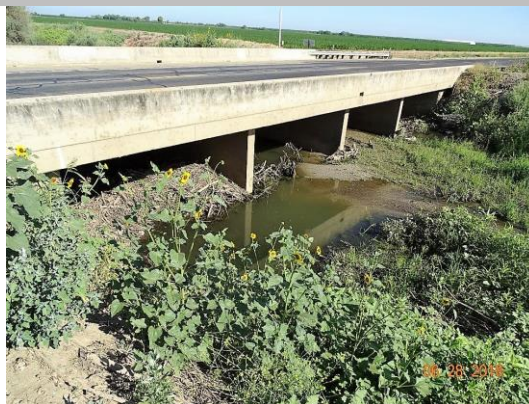
Photo 1 of 2 : CH_2018_NA0013_35_95_20180712_00093.jpg

Inspector Comments: Brush debris blocking inlets underneath the crossing needs to be cleared.

View of debris underneath crossing. Summer 2018

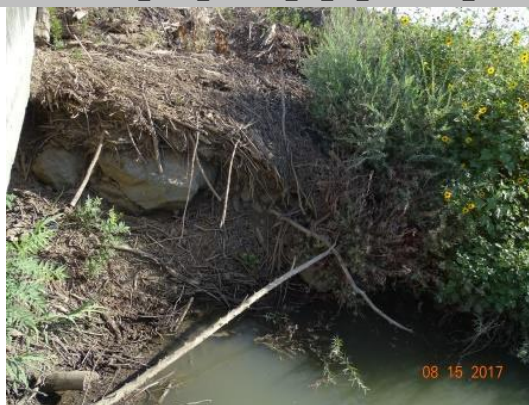
Photo 2 of 2 : CH_2018_NA0013_35_95_20180608_00042.jpg

Looking at the Hwy 59 Crossing driftwood and other material lodged against the inlet side of the bridge blocking off 2 of the 4 inlets. Summer 2017

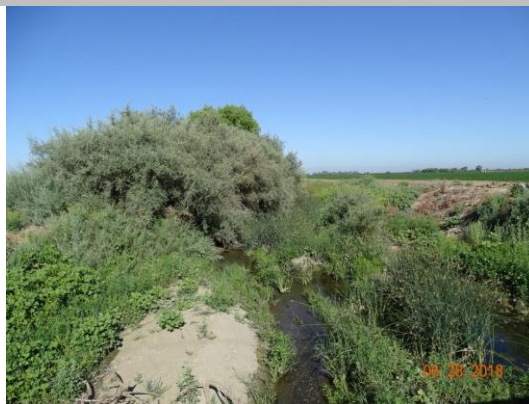
Photo 1 of 2 : CH_2018_NA0013_35_96_20180712_00094.jpg

Inspector Comments: The wild growth on both banks will likely impede flow and needs to be controlled.

View of vegetation in channel and along banks. Summer 2018

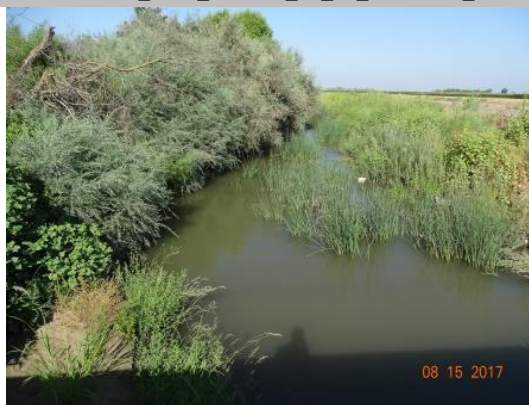
Photo 2 of 2 : CH_2018_NA0013_35_96_20180608_00043.jpg

Mariposa Creek looking downstream from Hwy 59. Summer 2017

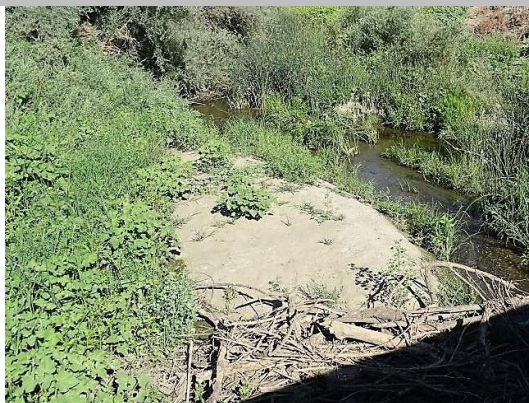
Photo 1 of 2 : CH_2018_NA0013_35_97_20180712_00095.jpg

Inspector Comments: Non-aquatic grasses present on shoal.

View of the shoal in the channel. Summer 2018

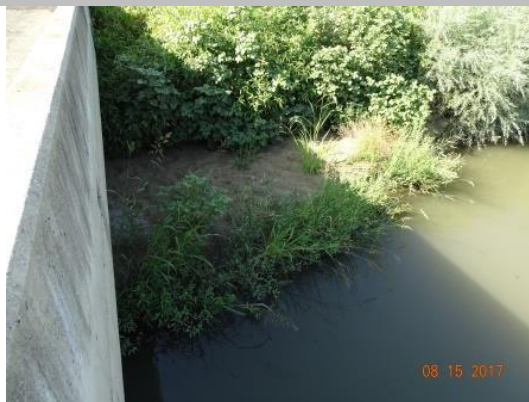
Photo 2 of 2 : CH_2018_NA0013_35_97_20180608_00044.jpg

Rating **	M	Issue No.	97 (cont)	GPS Lat/Long
Issue Type +	Ma	Location *		37.233949 °
Category	Rivers, Channels & Designated Flood			-120.488009 °
Item	Shoaling / Sedimentation			
DWR ID	DWR_NA0013_35_c _ 2016_97			
Action/Comments				
Inspector Comments: Non-aquatic grasses present on shoal.

View of the shoal in the channel. Summer 2017

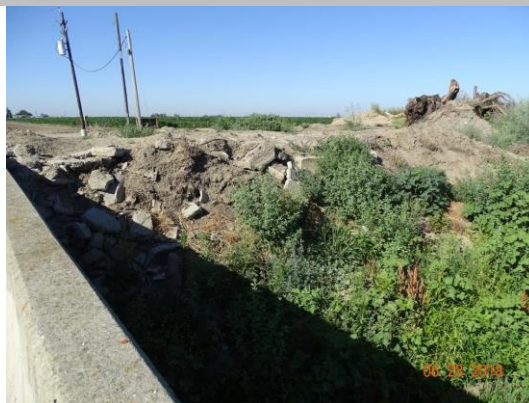
Photo 1 of 1 : CH_2018_NA0013_35_99_20180712_00096.jpg

Rating **	A	Issue No.	99	GPS Lat/Long
Issue Type +	Ma	Location *		37.233949°
Category	Rivers, Channels & Designated Flood			-120.488009°
Item	Revetments			
DWR ID	DWR_NA0013_35_c_2016_99			
Action/Comments				
Inspector Comments: Some concrete riprap exists on the left bank.

View of revetment on left bank. Summer 2018

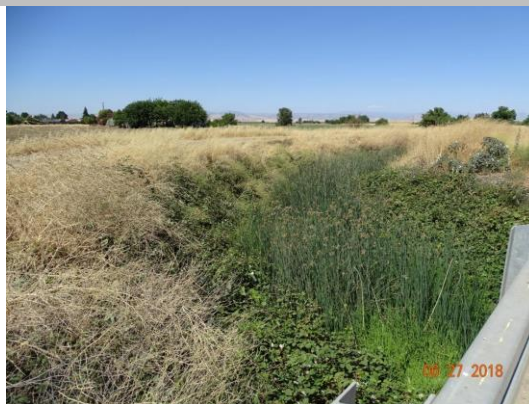
Photo 1 of 2 : CH_2018_NA0013_36_1_20180712_00033.jpg

Rating **	M	Issue No.	1	GPS Lat/Long
Issue Type +	Ma	Location *		37.287962 °
Category	Rivers, Channels & Designated Flood			-120.309167 °
Item	Vegetation & Obstructions			
DWR ID	DWR_NA0013_36_c_2012_1			
Action/Comments				
Inspector Comments: Some woody vegetation may impede flow and should be cleared at least 100 feet upstream.

View of vegetation in channel. Summer 2018

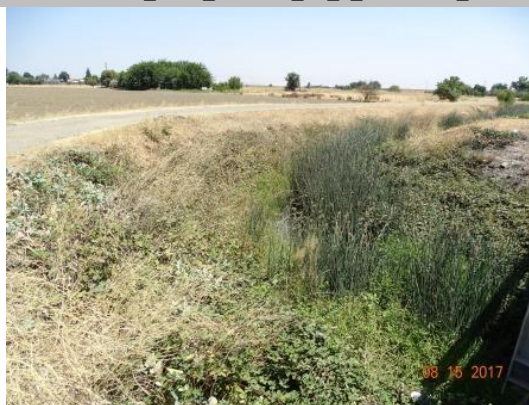
Photo 2 of 2 : CH_2018_NA0013_36_1_20180608_00001.jpg

Upstream view from the Childs Ave. crossing. Summer 2017

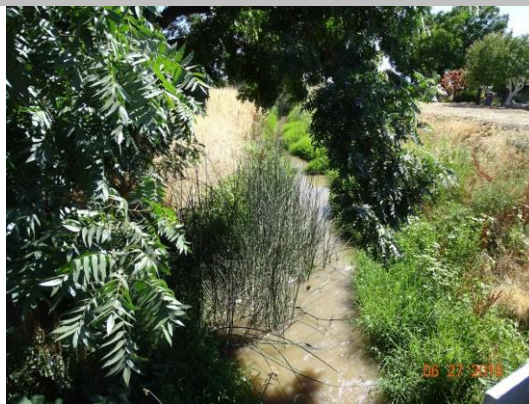
Photo 1 of 2 : CH_2018_NA0013_36_6_20180712_00034.jpg

Inspector Comments: Some vegetation present, but does not appear to be enough to impede flow.

View of vegetation in the channel. Summer 2018

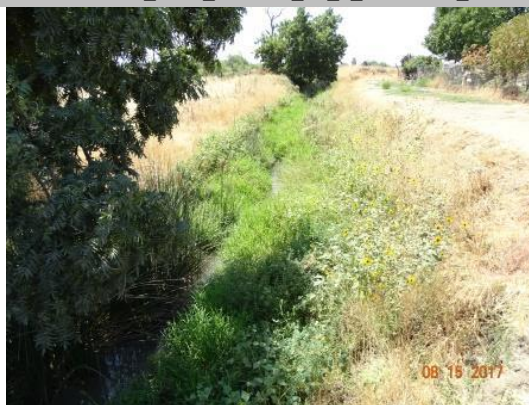
Photo 2 of 2 : CH_2018_NA0013_36_6_20180608_00002.jpg

Downstream view from the Childs Ave. crossing. Summer 2017

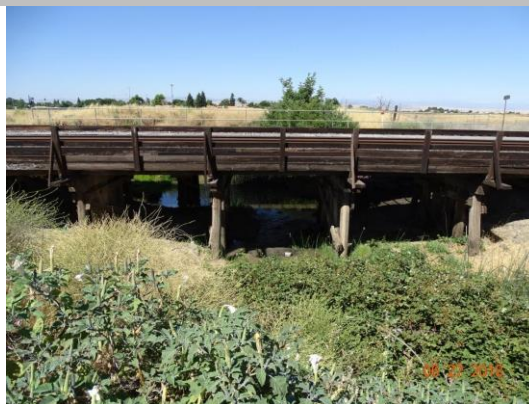
Photo 1 of 3 : CH_2018_NA0013_36_11_20180712_00035.jpg

View of vegetation in channel. Summer 2018

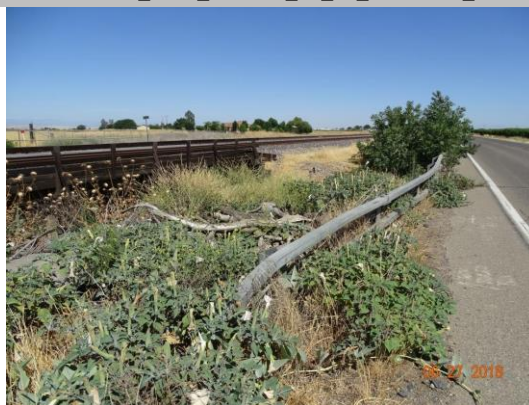
Photo 2 of 3 : CH_2018_NA0013_36_11_20180712_00036.jpg

View of vegetation and driftwood adjacent to road crossing. Summer 2018

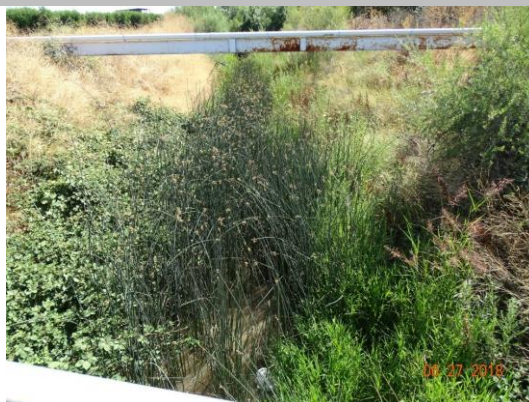
Photo 1 of 3 : CH_2018_NA0013_36_16_20180712_00037.jpg

Rating **	M	Issue No.	16	GPS Lat/Long
Issue Type +	Ma	Location *		37.284393 °
Category	Rivers, Channels & Designated Flood			-120.315460 °
Item	Vegetation & Obstructions			
DWR ID	DWR_NA0013_36_c_2012_16			
Action/Comments				
Inspector Comments: Woody vegetation may impede flow in the future and should be cleared at least 100 feet downstream.

View of vegetation in the channel. Summer 2018
